ADDENDUM #2

**Reroof Project at Edison High School Pool Building
Bid No. 24-05**

Re: Edison High School, Pool – Roof Replacement

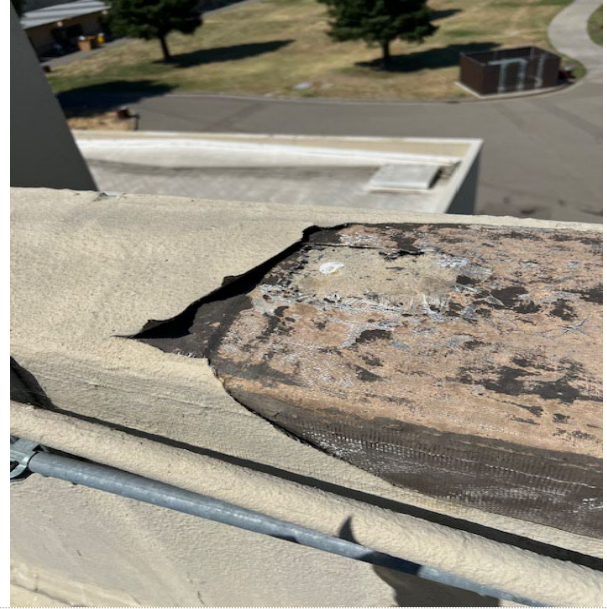
Brown Mastic/Sealant at Roof Cap

Location: 02A, Brown Sealant at Roof Cap Pool Roof, West Side

Sample Layers	Asbestos Content
Brown Sealant with Silver Paint	2% Chrysotile
White Woven Material	ND
Composite Non-Asbestos Content:	15% Glass Fibers
Sample Composite Homogeneity:	Poor

Since the asbestos containing materials are greater than 100 square feet a registered abatement company will be required for removal. The abatement must be conducted by a contractor registered with Cal/OSHA as an asbestos abatement contractor.

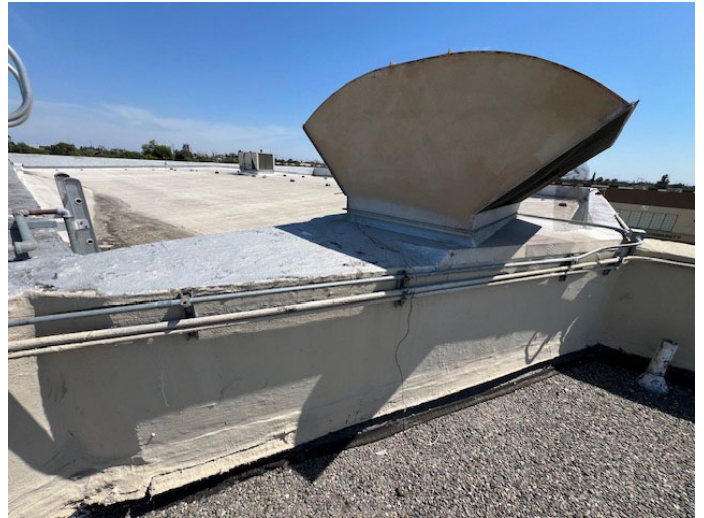
Silver Paint at Vent – Asbestos Containing

Location: 06A, Silver Paint Pool Roof, Northeast Corner at Vent

Sample Layers	Asbestos Content
Gray/Black Roofing Material with Silver Paint	< 1% Chrysotile
White Woven Material	ND
Tan Roofing Material	ND
Composite Non-Asbestos Content:	15% Glass Fibers
Sample Composite Homogeneity:	Poor

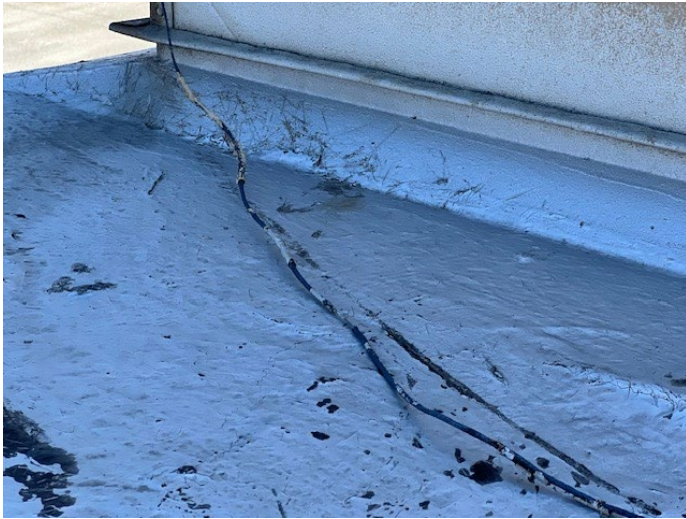
Silver Paint-Asbestos Containing
